case study

Japanese tire manufacturer avoids downtime and a saves \$63K

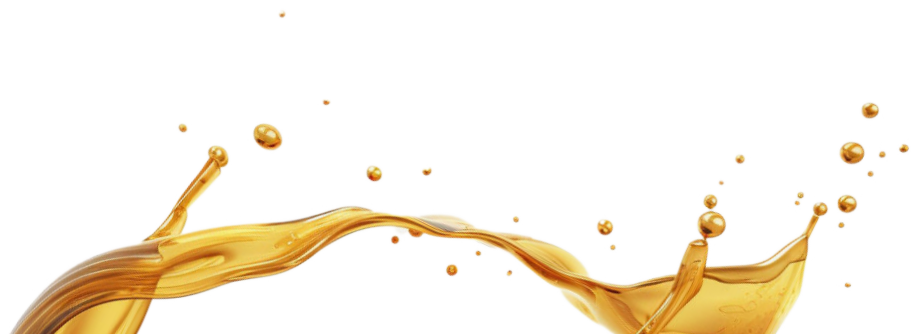
MPC VALUES

After adding DECON, the MPC levels decreased from 54 to 12, and the TAN levels normalized. This allowed the plant to continue operating efficiently without any loss in production or increase in carbon emissions.

They added **DECON™** to the turbine to control the deposit levels affecting its performance.
